City of Biggs

MEMORANDUM

SUBJECT: Piping of Valley Gutters

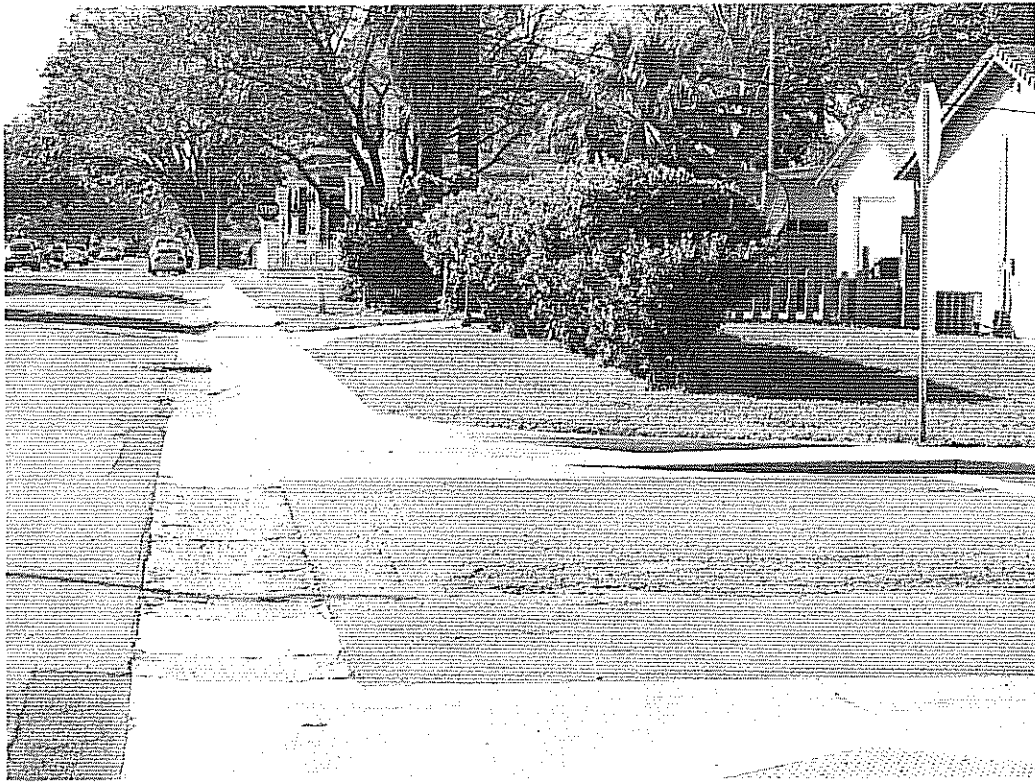
Existing valley gutter intersection

It is Staff's understanding that the reason this topic was brought forth for discussion was to develop a solution to minimize the "dips" that are present at a few of the deteriorating valley gutter crossings throughout the City. It is the City's wish to repair and modify the existing valley gutter crossings to provide residents with better vehicular travel. The cause of these "dips" is related to how narrow the existing valley gutters are (2' wide), old age, structural section failure, and older construction practices. Valley gutters were originally installed in the City many years ago to maximize surface drainage, as the City does not have sufficient underground storm drain infrastructure to allow for drainage inlets at all intersections. A newer type of intersection would have a smooth path of vehicular travel in all directions, with proper underground storm drain infrastructure.

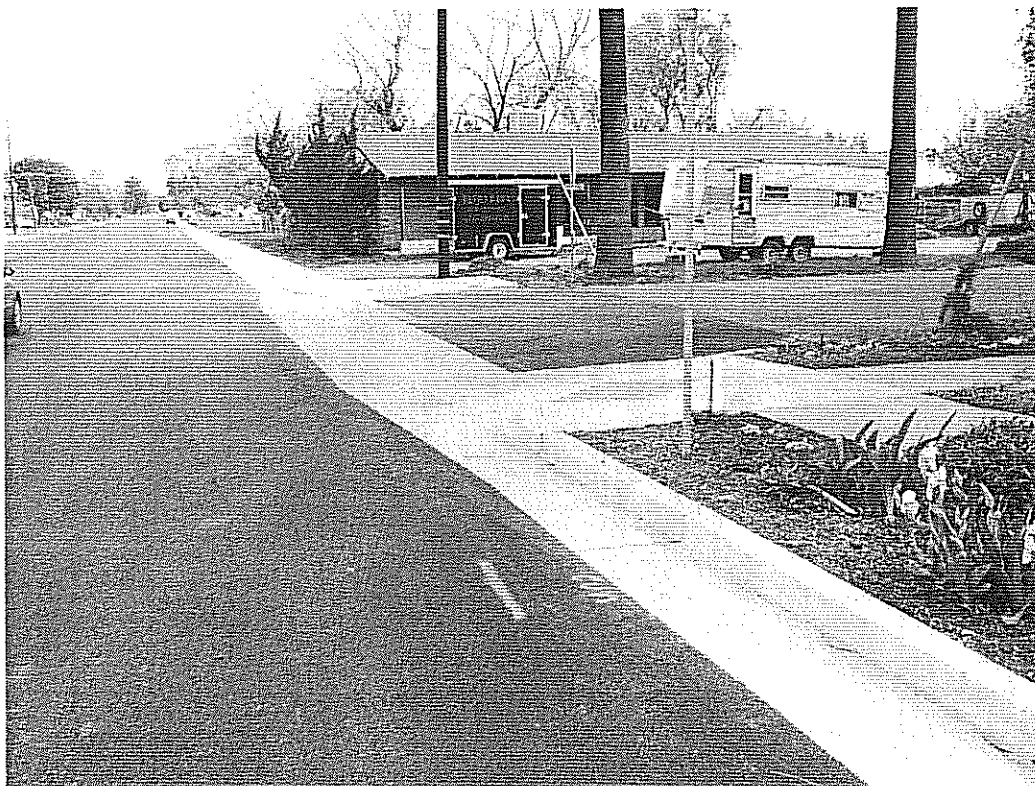
Potential valley gutter repair (not the same intersection as previous photo)

Engineering and Public Works Staff believe that the most financial and functional method to address deteriorating valley gutters would be to keep the existing surface drainage scheme and replace the existing valley gutters with new wider sections.
